# **ROUTE 1 CORRIDOR MP 5.0 to MP 15.0 SAFETY IMPACT TEAM REVIEW**

**May 19-21, 2003**

Mr. Jack Lettiere, Commissioner  
New Jersey Department of Transportation

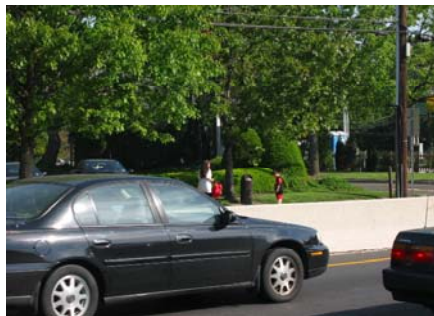
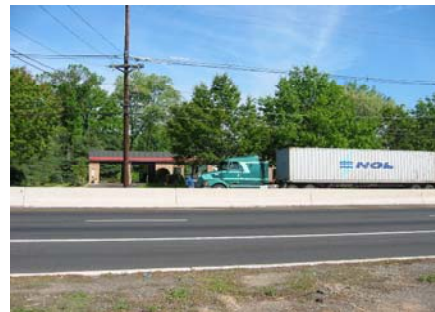
- The northbound right-turn lane appears to be too long at approximately 1,000 feet. The first advance intersection lane control sign is posted approximately 500 feet after the start of the designated right-turn only lane. The second advance intersection lane control sign is 335 feet north of the first sign and is partially blocked by the new Mercer County Community College (logo) directional sign that is located between the two lane control signs.
- The pavement friction is low on Route 1 approaching the intersection.
- There are several bus stops along Route 1 that are poorly marked (*see photos below*).

- ✓ Replace signs with low retro-reflectivity and replace the mast arm signs with increased letter size.
- ✓ Sign bus stops along Route 1 and prohibit parking in front of them.

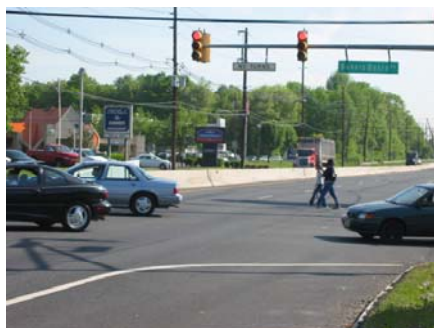
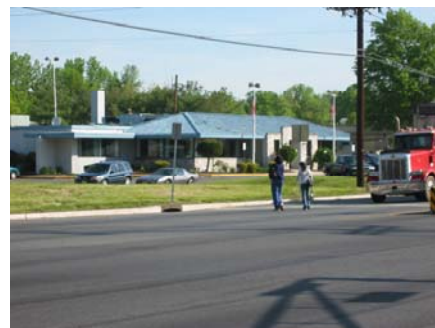
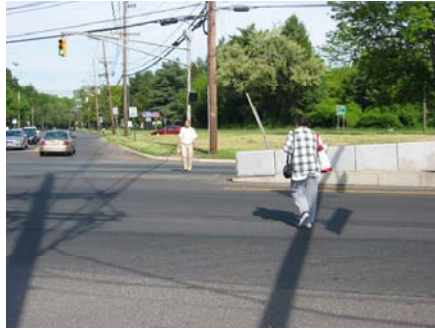
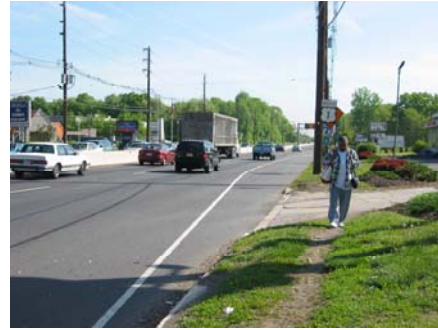
- The regulatory signs need improved retro-reflectivity.
- The mast arm signs are old and the letter size too small.
- Lack of adequate pedestrian facilities (no crosswalks, sidewalks or curb ramps) and several pedestrians were observed crossing Route 1 (*see photos below*).

However, there is a crosswalk shown on the approved traffic signal plan that was either not installed after the last resurfacing project or has faded away.

- ✓ Replace existing 8” signal heads for split left-turn signals with 12” four-section signal heads.<sup>1</sup>
- ✓ Provide high-visibility crosswalks on three legs of the intersection and across all jughandle ramps.<sup>1</sup>

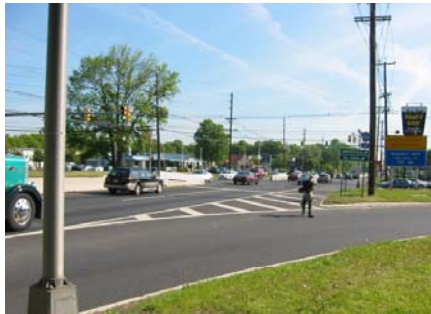
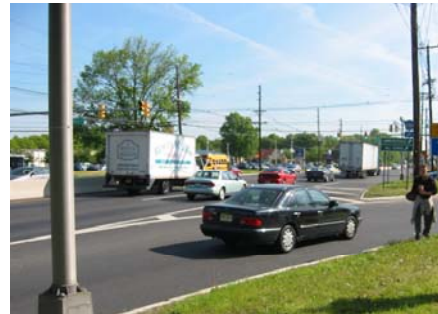
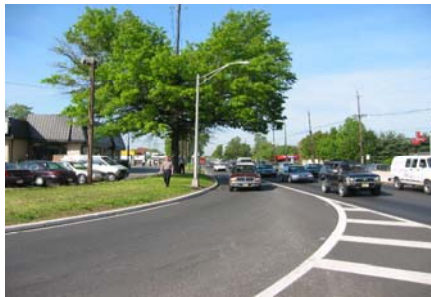
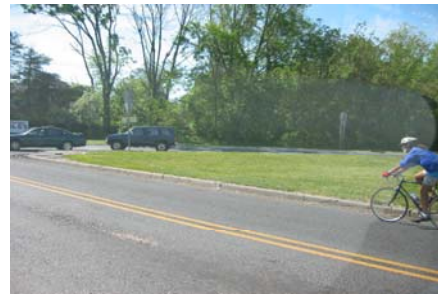
- The northbound jughandle geometry is not adequate for trucks. In addition, the jughandles lack provisions for pedestrian and bicycle crossings such as striped crosswalk, shoulder or bike lane (*see photos below*).

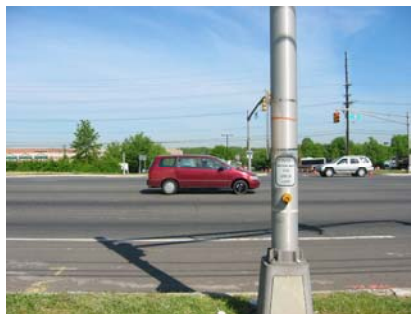
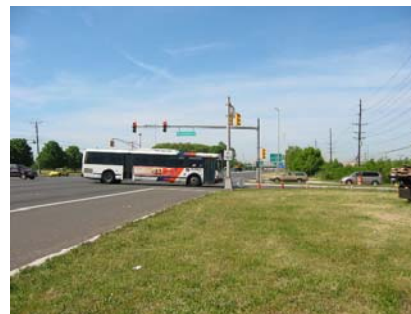
- An angle crash problem exists with southbound motorists running the red light.
- Pedestrian push buttons are present with no striped crosswalks or sidewalks and there is a worn path along Route 1. There are two bus routes along Route 1 with poorly marked bus stops. *(See photos)*

- ✓ Replace the existing side street signal heads with split left-turn arrow signals (four-section signal heads) and add back plates to signal heads where appropriate.
- ✓ Modify the traffic signal timing to improve traffic flow through the intersection.
- ✓ Provide pedestrian countdown signal heads.
- ✓ Stripe high-visibility crosswalks across all legs of the intersection and across jughandle ramps.
- ✓ Provide bus stop signs along Route 1.

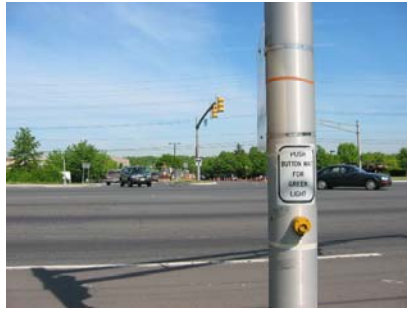
- There is a sign on the traffic signal pole located on the southwest corner of the intersection that indicates, "PUSH BUTTON WAIT FOR GREEN LIGHT", but it is not clear which signal is to be viewed *(See photos)*.

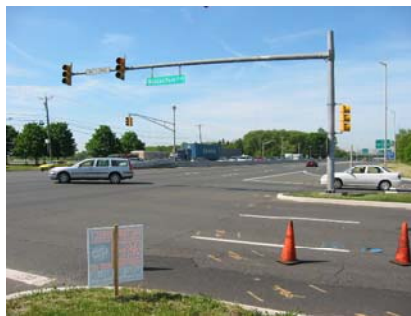
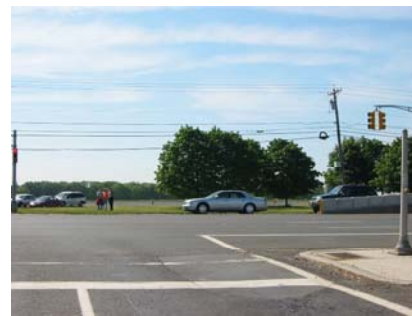
- The traffic signal cycle length is 240 seconds during weekday AM peak hour (6:30-9:30 AM) and then converts to 90-second background cycle at 9:30 AM. A 120-second cycle is employed for the PM peak hour beginning at 3:30 PM. In addition, too much time is allotted to the side street movements midday, weekends and during the afternoon peak hour.
- There is an extremely long crossing distance for pedestrians at the intersection (*See photos*).

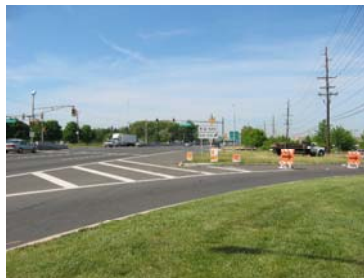
- Crosswalks are not provided across jughandle entrances or exit ramps (*See photos*).

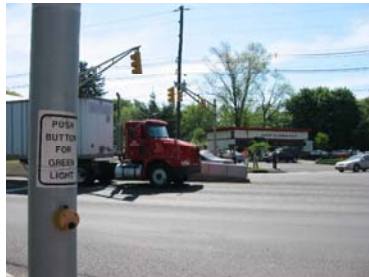
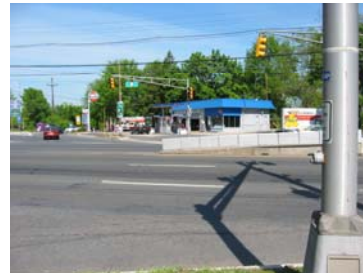
- Crosswalks do not exist between the pedestrian push buttons, which are currently located on the northerly corners of the intersection. In addition, traffic signals are not visible to pedestrians at the location of the push buttons. (*See photos*)

- ✓ Implement Penns Neck EIS recommendations.<sup>1</sup>

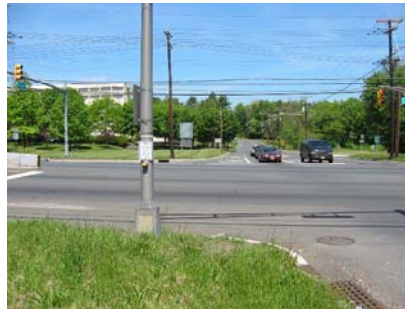
- Similar to the Franklin Corner Road/Bakers Basin Road intersection, there are insufficient gaps available along the westbound approach of Ridge Road for northbound left-turns movements from the jughandle to exit during the peak hours.
- The vertical sight distance along the northbound approach to the traffic signal may be inadequate.
- Similar too much of the rest of the Route 1 study corridor, there is a lack of pedestrian facilities at this location (*See photo*).

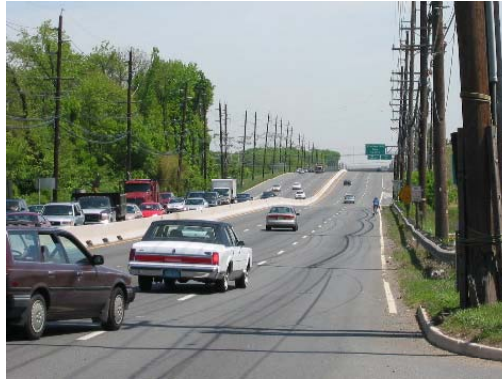
- Shoulders do not exist along Route 1 for bicyclists (*See photo*).

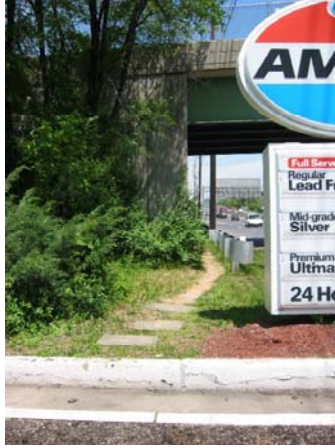
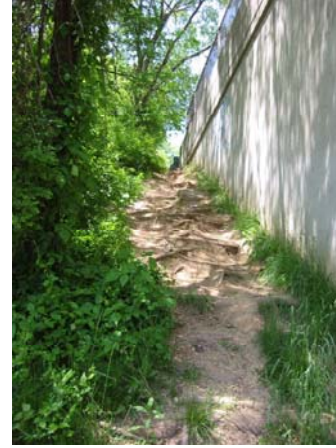
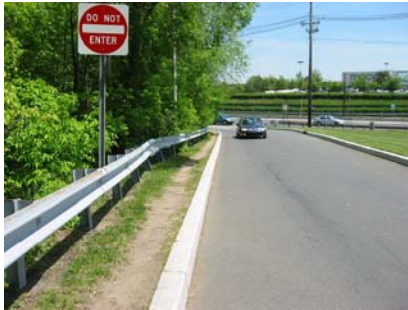
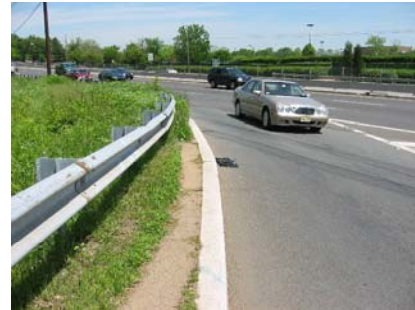
- The acceleration lane from Quakerbridge Mall to Route 1 southbound is not of sufficient length (approximately 150 feet) due to geometric constraints associated with the adjacent Amoco site and loss of shoulder.
- Worn path up to overpass shows the desire for pedestrians to travel from the southbound side of Route 1 to the Mall located on the northbound side of Route 1 (*See photos*).

- ✓ Investigate converting the existing yield condition along the ramp to a stop condition and change geometry with striping.<sup>1</sup>
- ✓ Install oversized merge sign so that southbound motorists are aware of the merge from the Quakerbridge Mall ramps.<sup>1</sup>
